Manhole Inspection Summary

Manhole # S33QQ_032MH

Insp Date: **4/23/07 9:49 AM**

Location Address: **2445 CHARLES ST**

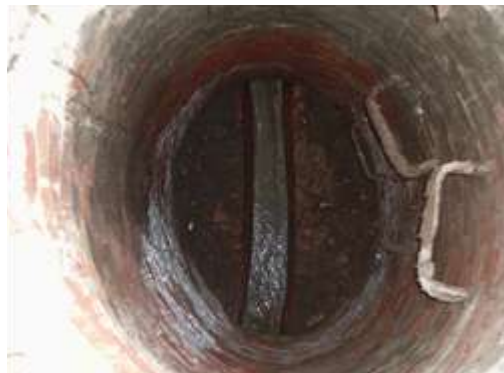
Top View

Corroded and missing steps. Evidence of surcharge - Bench debris.

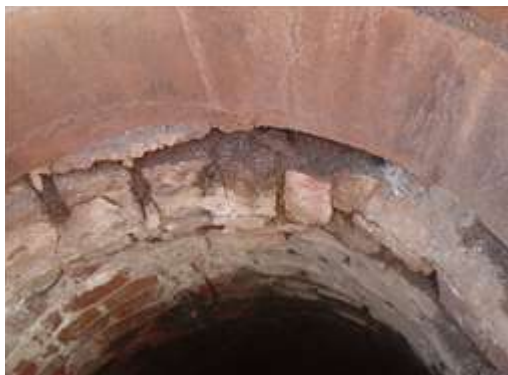
Defect

Adjustment deterioration and infiltration. Barrel infiltration - other side.

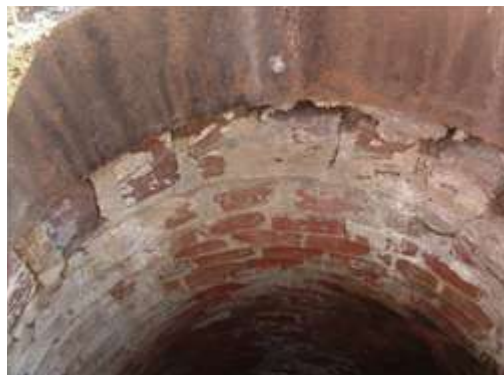
Defect

Adjustment deterioration and infiltration. Barrel infiltration.
